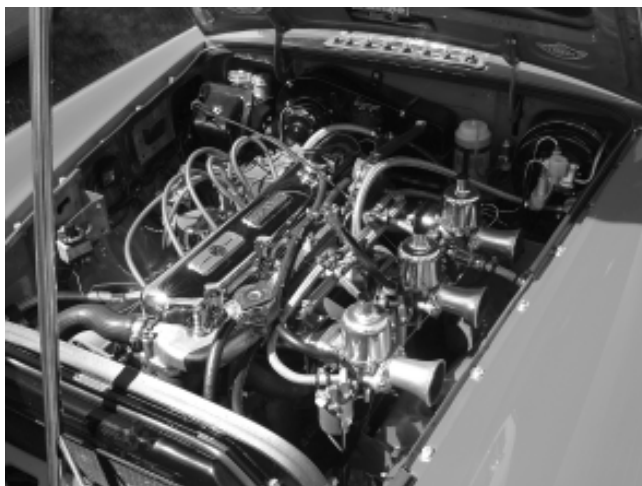
Photo Top Right: **The GT was launched at the same time as the roadster.**
 2nd From Top: **There was no “rubber bumper” version of the “C”.**
 3rd From Top: **This restored car has non-standard Compomotive wheels.**
 Lower Right: **A Downton Stage 3 specification engine installed in the car illustrated above, with triple SU carbs and other tuning modifications.**

The large, almost lazy, engine in the “C” means it is not over-stressed (especially in automatic models). Together with the gearbox and rear axle, the engine is not particularly prone to problems and if serviced properly, they are long-lived items. The engines also do not usually suffer from overheating or loss of oil. The C-Series engine was shared only with the Austin 3-Litre saloon (1967-71) but note that the Austin used a version with a lower compression ratio.
